Appendix C Nozzle PFORs

Final Postflight Hardware Evaluation Report RSRM-29 (STS-54)

September 1993

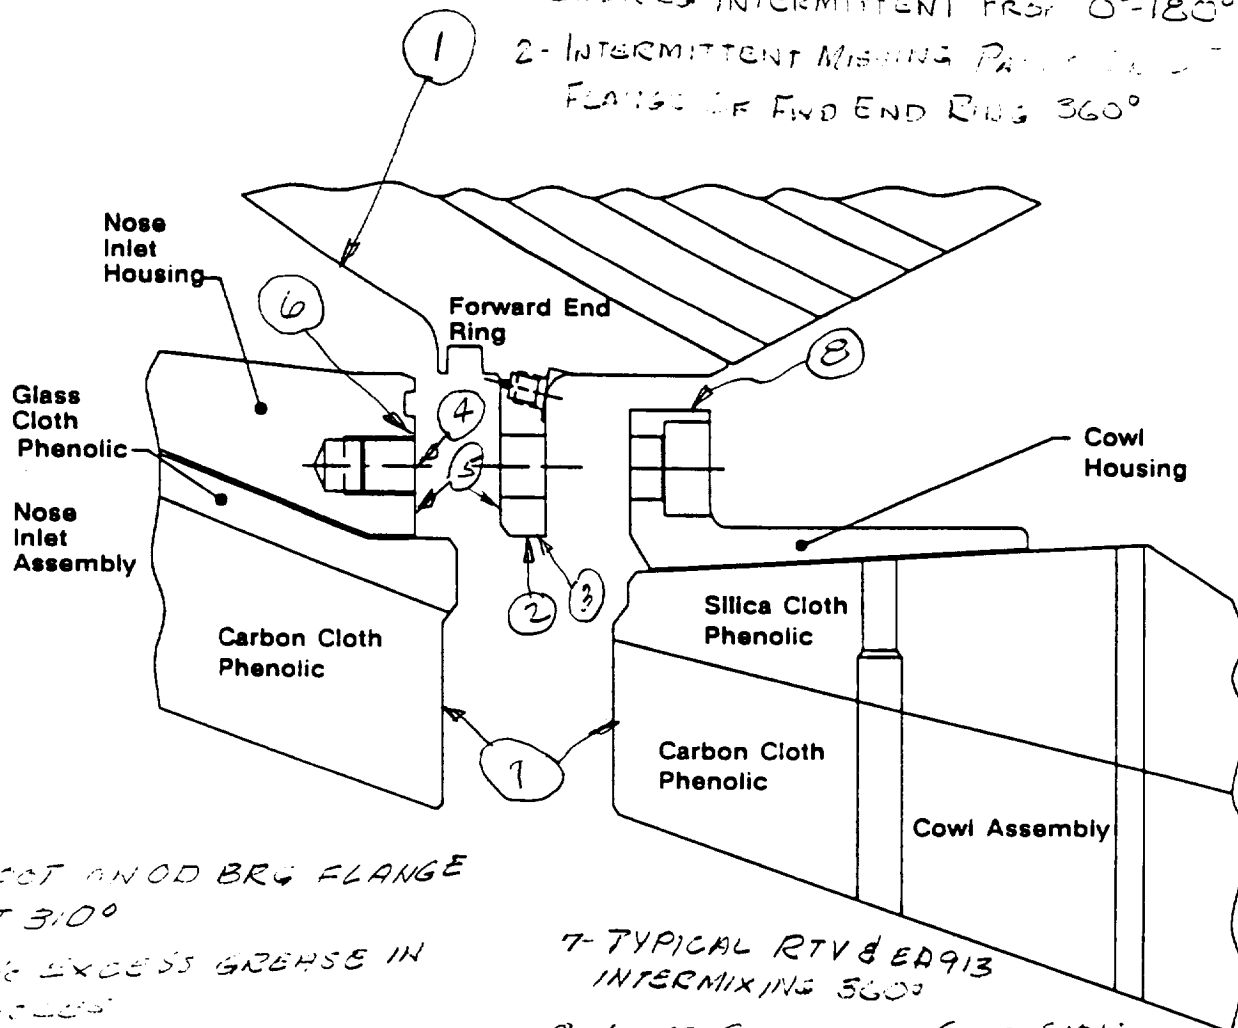
Nose Inlet-to-Flex Bearing-to-Cowl Joint (Joint #2) Condition Drawing Worksheet

- (32)
- 1-BUBBLED PAINT ON FWD FACE OF FLEX BEARING INTERMITTENT FROM 0°-180°
 - 2-INTERMITTENT MISSING PAINT ON FLANGE OF FWD END RING 360°

3-SOOT AND OD BRG FLANGE AT 310°

4-1/2" EXCESS GREASE IN HOUSING

8-LIGHT CORROSION CORROSION INTERMITTENT 360°

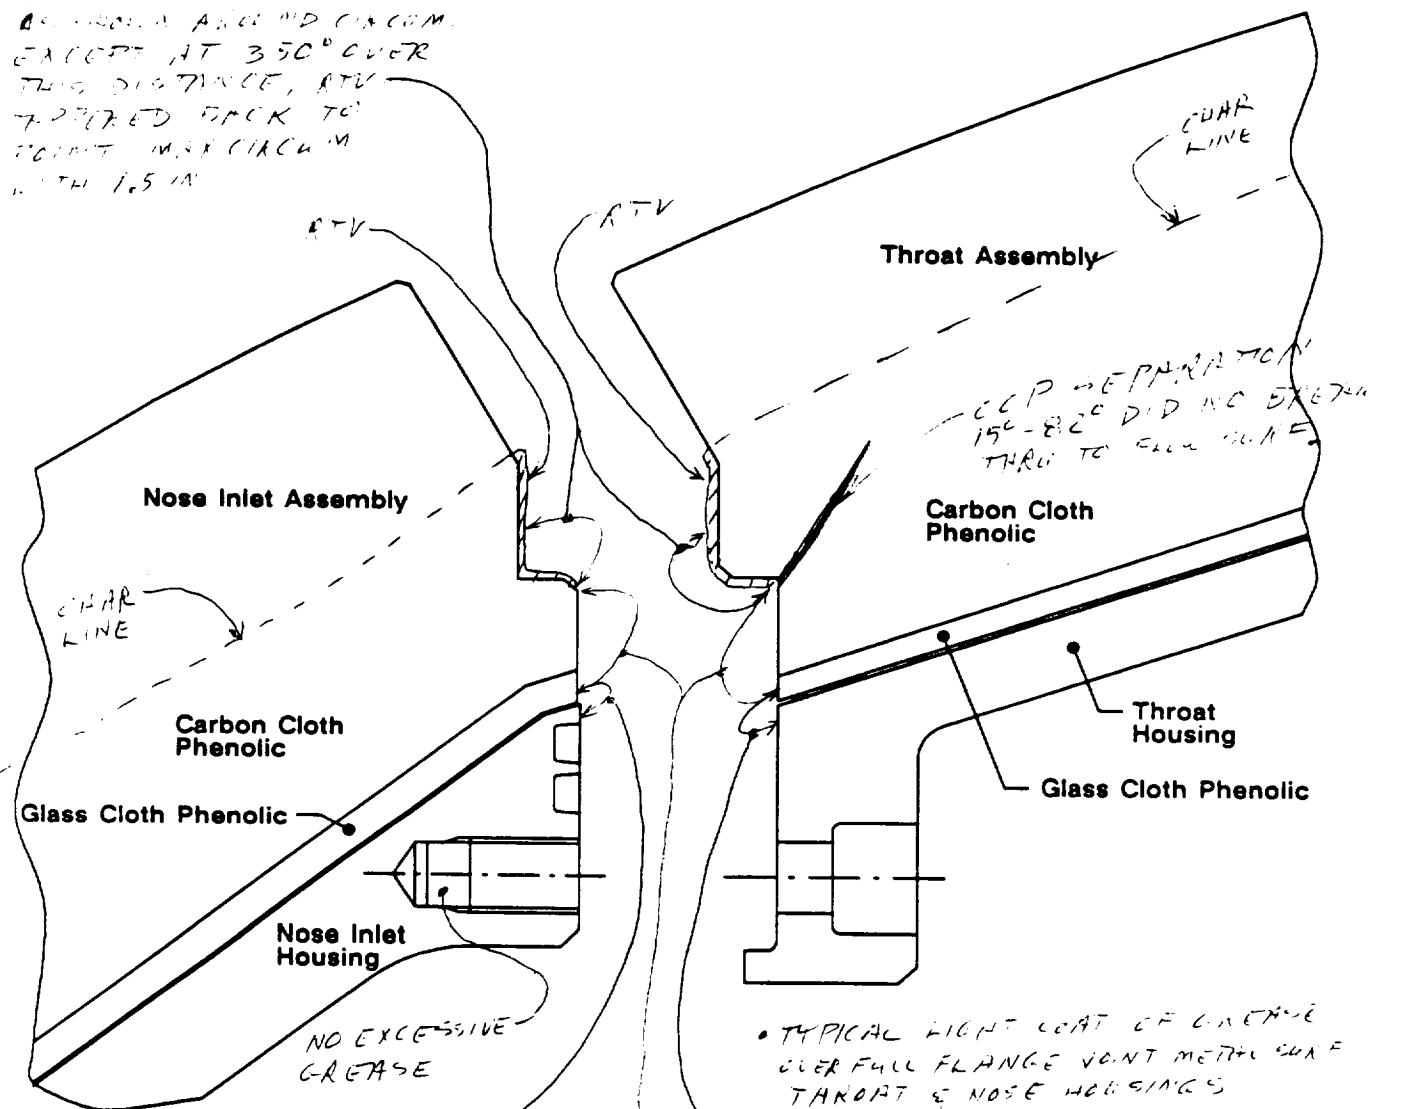
POSTFLIGHT OBSERVATION RECORD (PFOR) C-4
Nose Inlet-to-Throat Joint (Joint #3) Condition Drawing Worksheet

RTV BELOW CHAR LINE
BEHIND AROUND CIRCUM.
EXCEPT AT 350° OVER
THIS DISTANCE, RTV
TAPERED BACK TO
POINT MAX CIRCUM
WITH 1.5 IN

• LIGHT-TO-MEDIUM AL. OXIDE
CORROSION AROUND FULL
CIRCUMFERENCE
• NO BOLT HOLE OR HORIZONTAL
CRACK DAMAGE

• TYPICAL LIGHT COAT OF GREASE
OVER FULL FLANGE JOINT METAL SURF
THROAT & NOSE HOUSINGS
• LIGHT-TO-MEDIUM RUST CORROSION
AROUND FULL CIRCUMFERENCE
HEAVY RUST STAINS ON PHENOLIC
SURFACE 330°-360° AND INTERMITTENT
AROUND REMAINING CIRCUMFERENCE
• TYPICAL INTERM. METAL-TO-ADHESIVE
SEPARATIONS ON THROAT ONLY.

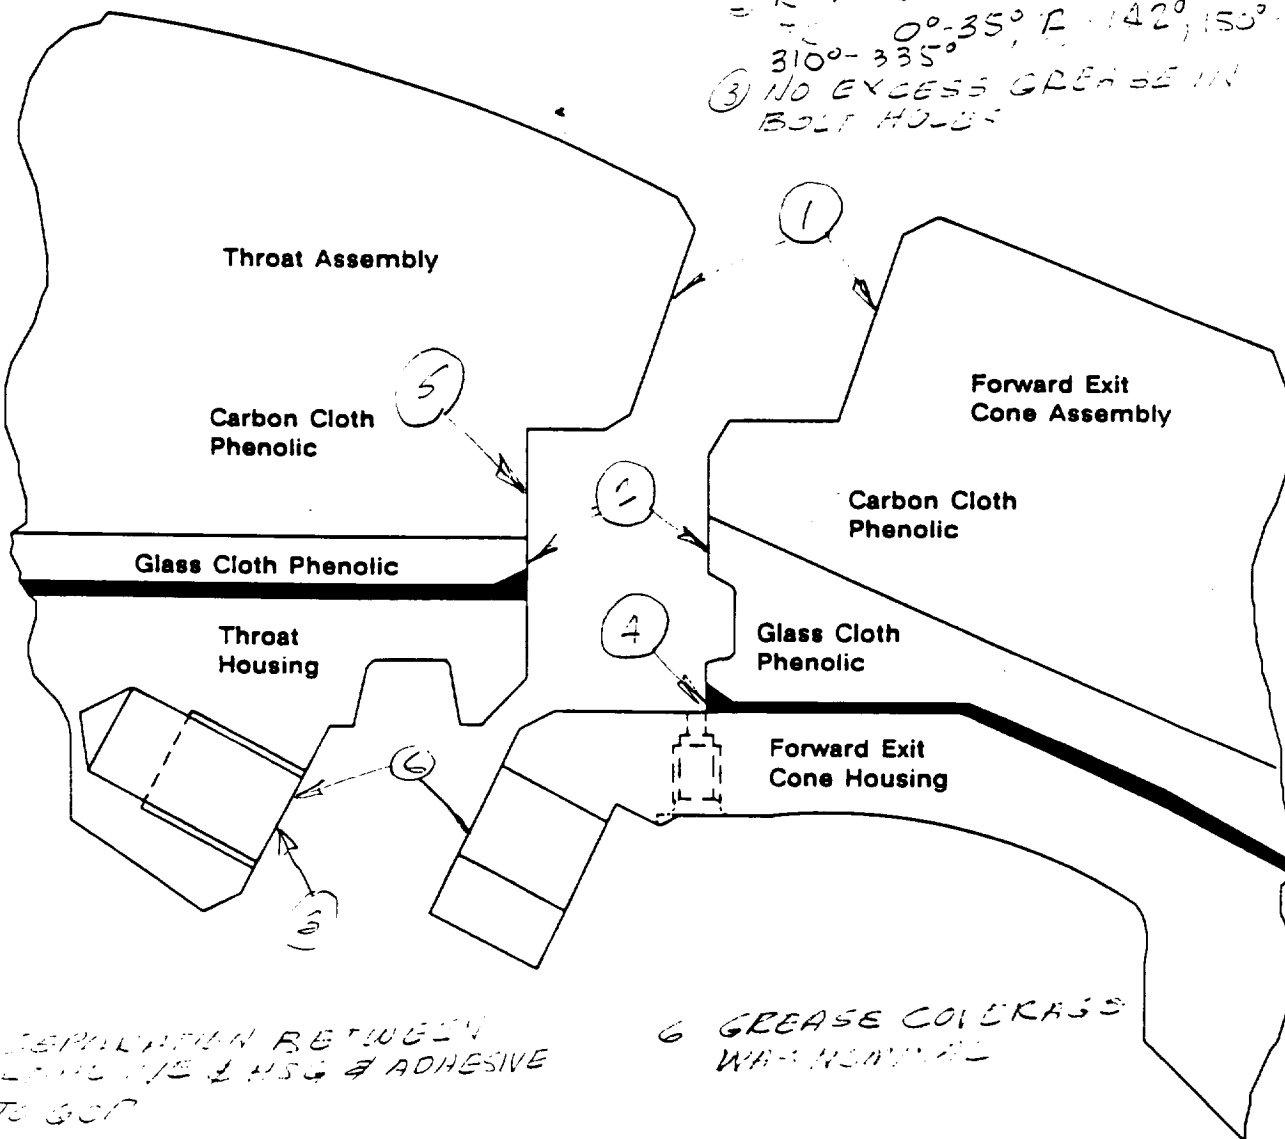
POSTFLIGHT OBSERVATION RECORD (PFOR) C-5
Throat-to-Forward Exit Cone Joint (Joint #4) Condition Drawing Worksheet

*ACTV BELOW DARK LINE
5000
5000
00-35° E 142° 150° 035°
310°-335°
③ NO EXCESS GREASE IN
BOLT HOLES*

*4 SEPARATION BETWEEN
FIBER GLASS & ADHESIVE
TO GCP*

*6 GREASE COVERAGE
WAS NOMINAL*

*5 PHENOLIC DISCOLORED
APPEARS TO BE RUST
FROM 310 THRU 3 TO 35°*

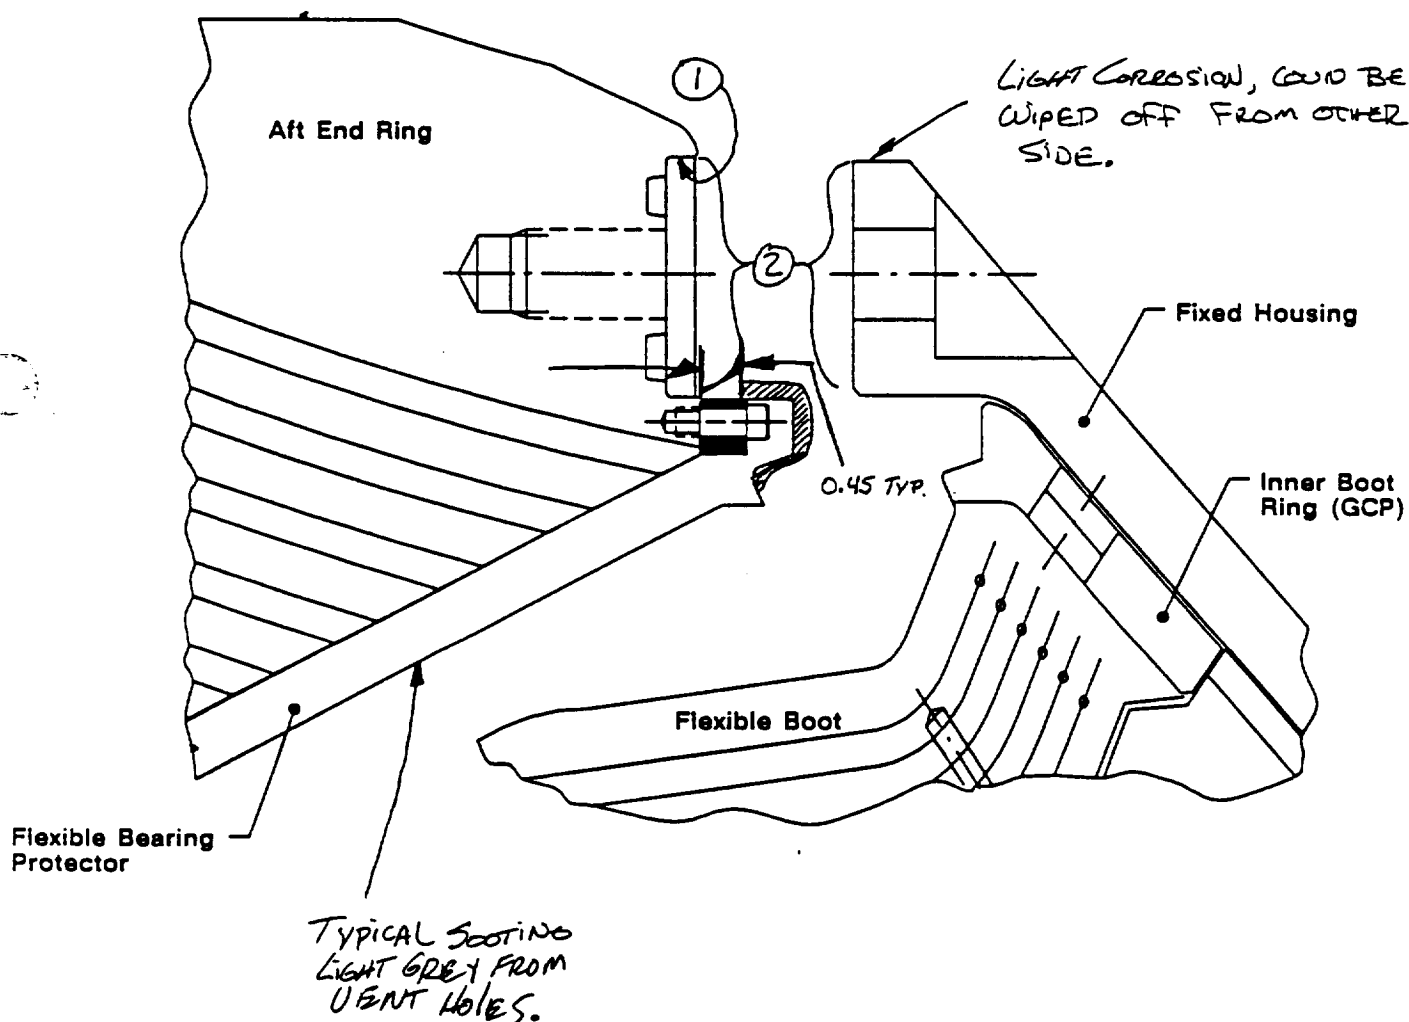
POSTFLIGHT OBSERVATION RECORD (PFOR) C-6
Aft End Ring-to-Fixed Housing Joint (Joint #5) Condition Drawing Worksheet

- ① ~~Light~~ to MEDIUM CORROSION INTERMITTENT 360°.
- ② NOMINAL GREASE COVERAGE.
- ③ RTV to PRIMARY 50°-107°, 225°-230°, and 240°-245°.

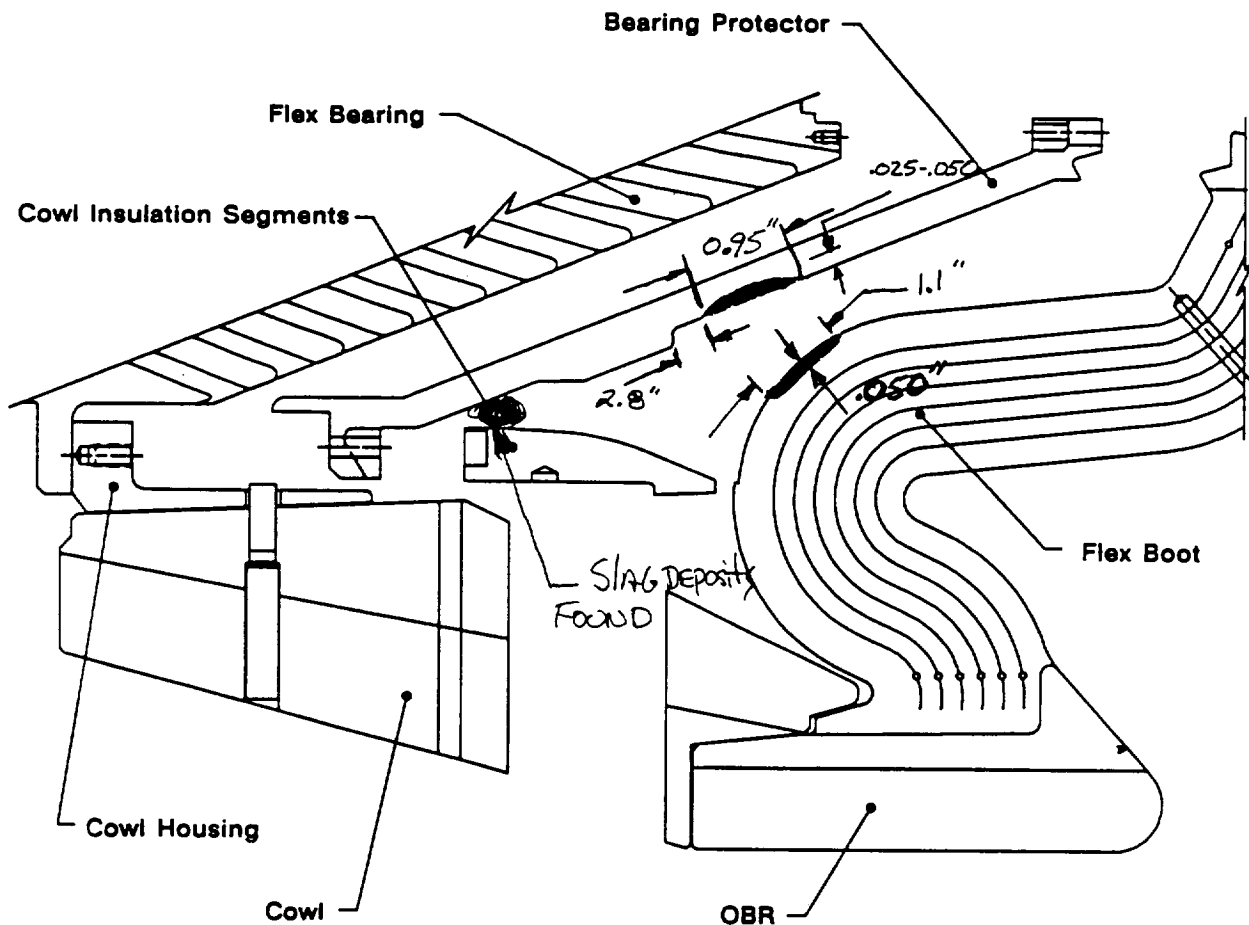
Description: EROSION ON BEARING PROTECTOR AND FLEX BOOT ID AT 50° VENT HOLE

- ① Small AREA OF EROSION ON FLEX BEARING PROTECTOR 2.8" AFT OF BELLY BAND IN LINE WITH VENT HOLE AT 50°. AREA MEASURES 3.6" CIRC. X 0.95" AXIAL WITH AN APPROXIMATE DEPTH OF 0.025"-0.050". SLAG DEPOSITS WERE FOUND IN CAVITY NEXT TO BEARING PROTECTOR AND COWL INSULATION. EROSION APPEARS TO BE CAUSED BY SLAG. SIMILAR CONDITIONS HAVE BEEN FOUND ON PREVIOUS FLIGHTS.
- ② MIRROR IMAGE OF BEARING PROTECTOR EROSION FOUND ON ID OF BOOT MEASURING 3.7" CIRC. X 1/16" ~~WIDE~~ WIDE, AND APPROX. 0.050" DEEP.
- ③ FWD B/L PROTECTOR SCREW AT 33° SHOWED SMALL (0.070 IN DIA) AREA OF BLACK CORROSION ON SIDE OF SCREW HEAD. SCREW WILL BE EVALUATED FOR POSSIBLE HEAT EFFECTS.

AREA OF EROSION LOCATED DIRECTLY IN LINE WITH 50° VENT HOLE.
APPEARS TO BE CAUSED BY SLAG.

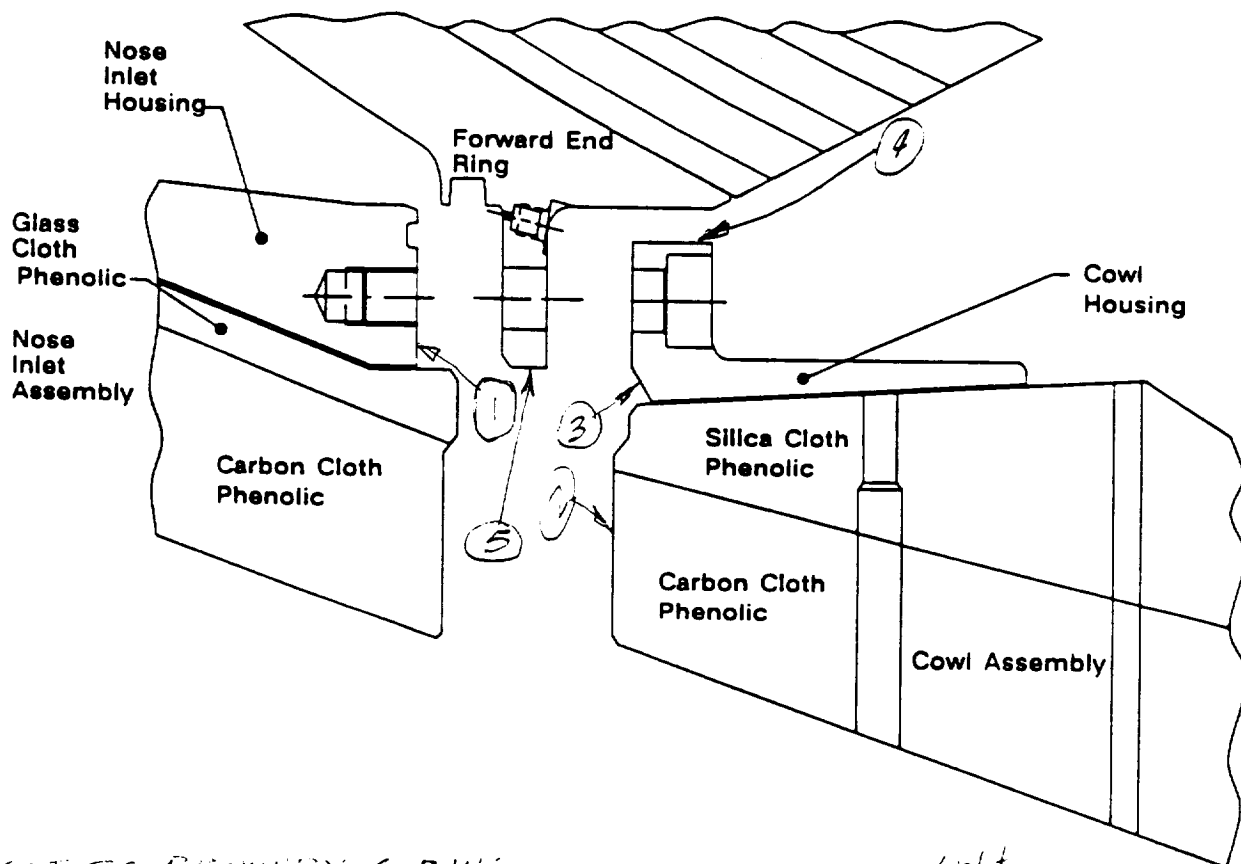
POSTFLIGHT OBSERVATION RECORD (PFOR) C-3
Nose Inlet-to-Flex Bearing-to-Cowl Joint (Joint #2) Condition Drawing Worksheet

1. SCOT TO FORWARD G-RING
AT 250°
2. RTV FULL COVERAGE 360°
TYPICAL INTERMIXING OF
CLOTH AND PHENOLIC

(3) INTERMITTENT ^{Light} CORROSION 360°
(4) LIGHT CORROSION ON AFT EDGE
OF COWL HSG ID FLANGE
(5) INTERMITTENT SMALL AREA OF
MISSING PAINT (360°)

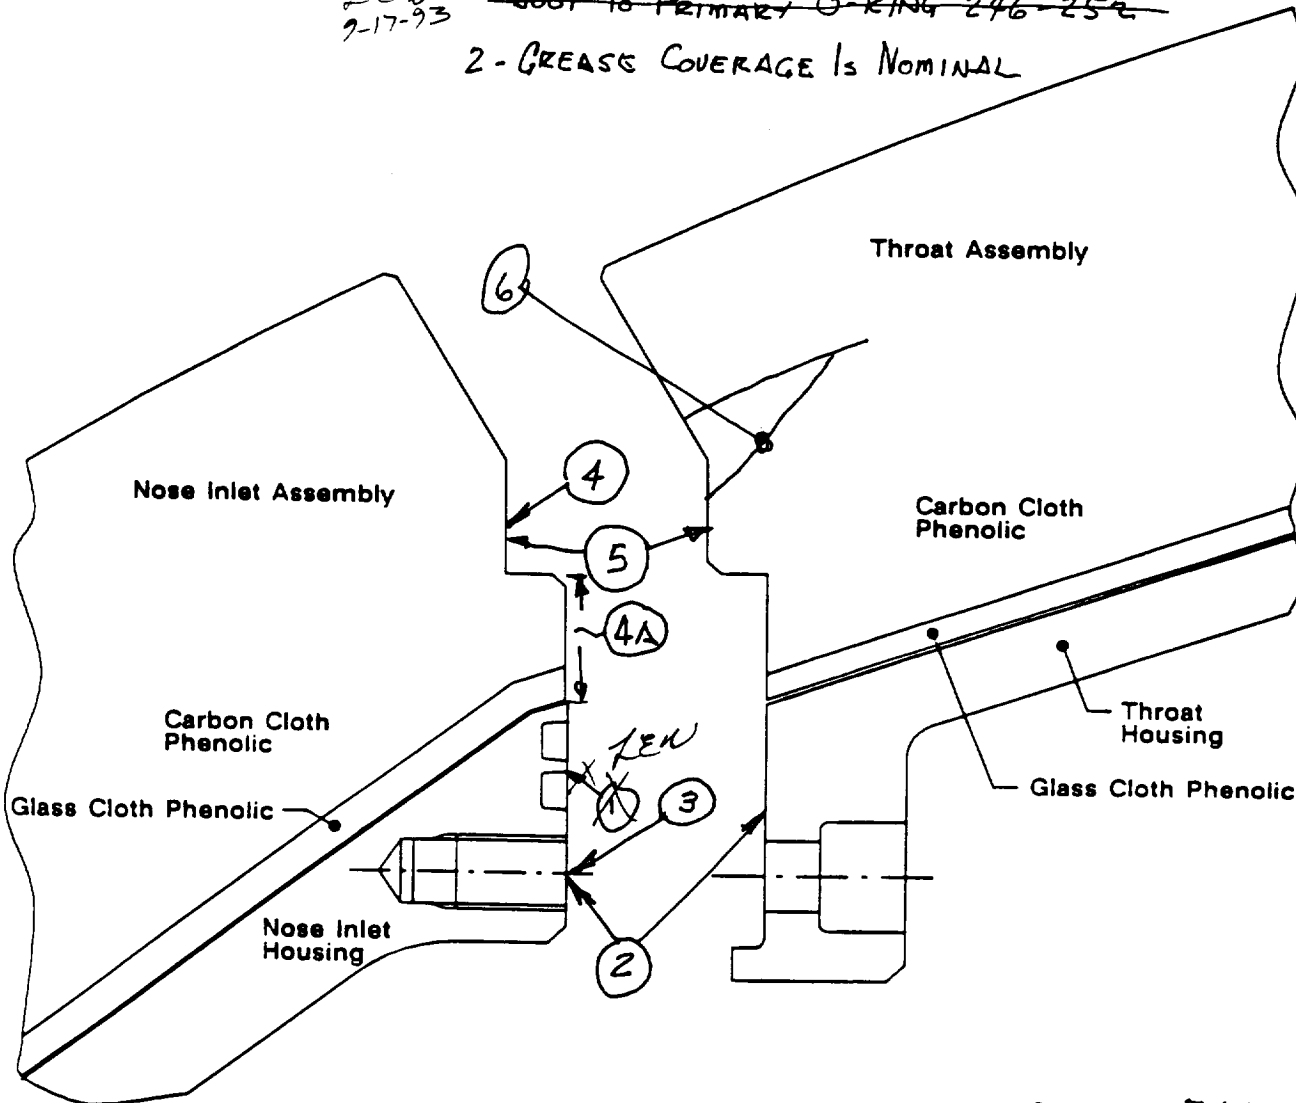
LEN
2-17-93
~~1 - TYPICAL SCALLOPED IN BETWEEN BOLT HOLES.~~
~~SOOT TO PRIMARY O-RING 246-252~~
2 - GREASE COVERAGE IS NOMINAL

3 - NO EXCESS GREASE IN BOLT HOLES

5 - RTV BELOW CHAR LINE 360
6 - PLY SEPARATION FROM 290° - 300°
GAP = .010

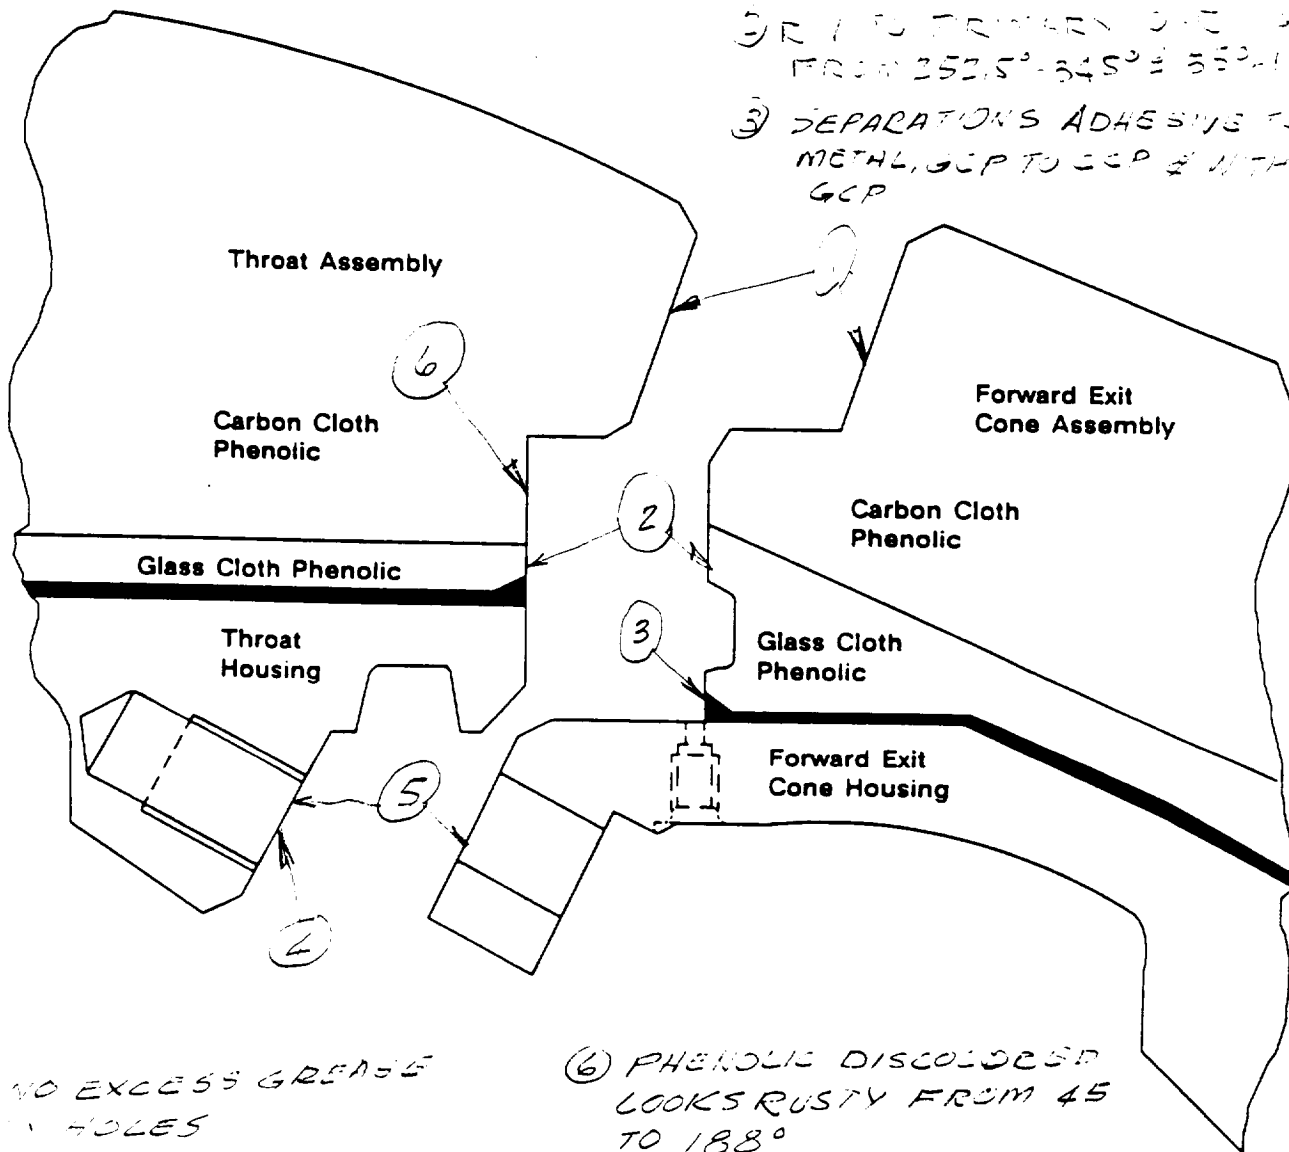
- ① RTV BELOW CHAR LINE FULL CIRCUMFERENCE
- ② RTV TO PRIMARY O-RING FROM 252.5°-345° & 355°-120°
- ③ SEPARATIONS ADHESIVE TO METAL, GCP TO CCP & WITHIN GCP

④ NO EXCESS GREASE IN HOLES
⑤ MINIMAL GREASE COVERAGE ON FLANGES

⑥ PHENOLIC DISCOLORED LOOKS RUSTY FROM 45 TO 188°

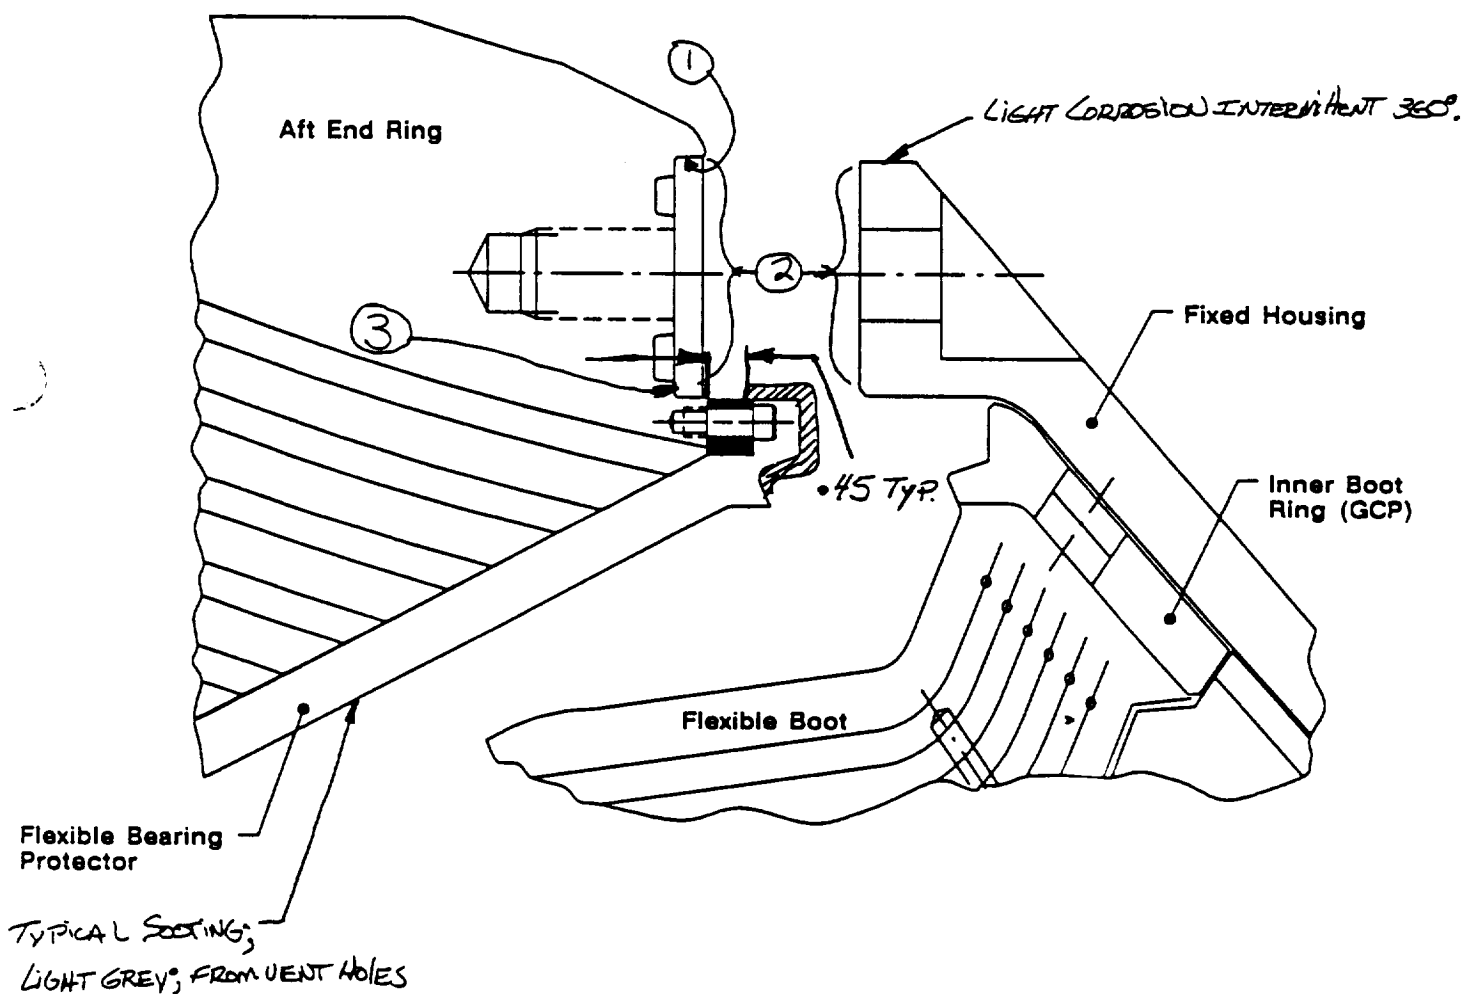
- ① MEDIUM CORROSION INTERMITTENT ~~360°~~ FROM 150°-0°-80°.
- ② NOMINAL GREASE COVERAGE. WATER IN NOTED AREA, APPEARS TO BE FROM DISASSEMBLY. LIGHT CORROSION ALSO FOUND IN NOTED AREA INTERMITTENT 360°.
- ③ RTV REACHED PRIMARY O-RING AT 40°-70°, 130°, AND 220°-250°
